686-US.EP
C14-161312 M/TRK
US.EP

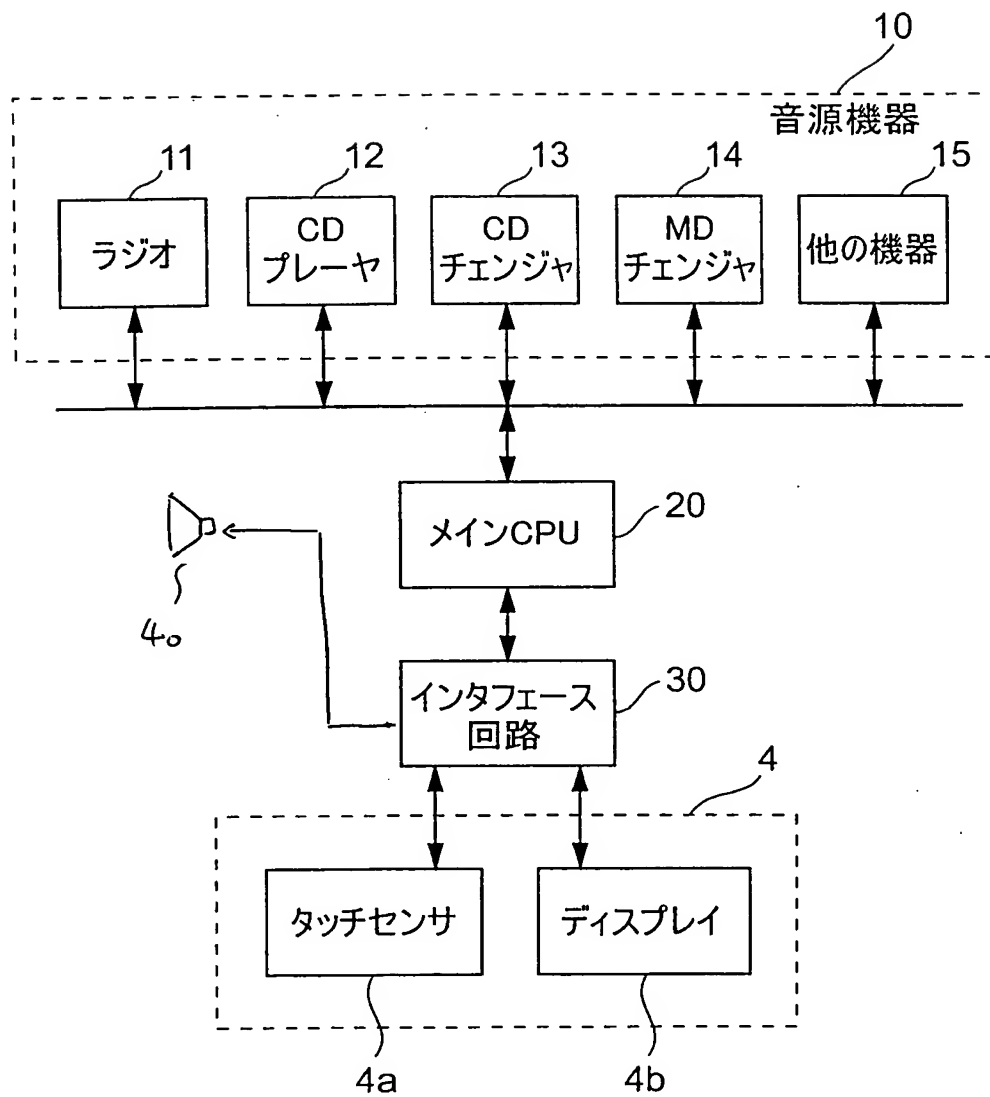
Fig.3

- 10 SOUND SOURCE EQUIPMENT
- 11 RADIO
- 12 CD PLAYER
- 13 CD CHANGER
- 14 MD CHANGER
- 15 OTHER EQUIPMENT
- 20 MAIN CPU
- 30 INTERFACE CIRCUIT
- 40 SPEAKER
- 4a TOUCH SENSOR
- 4b DISPLAY

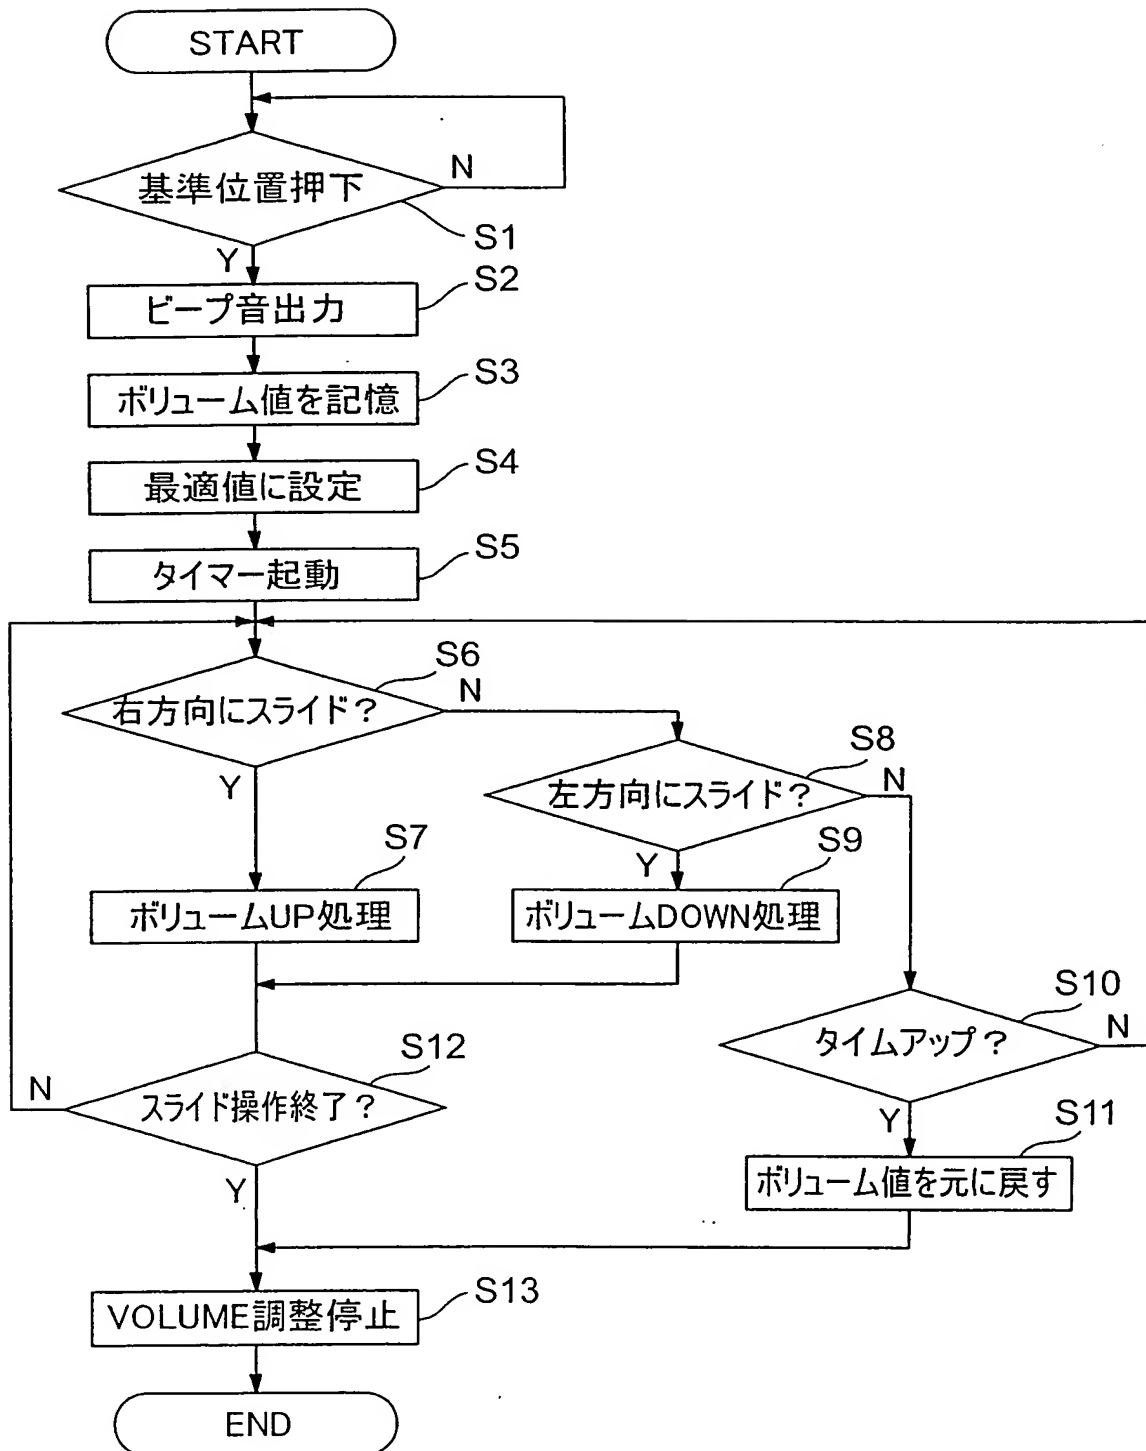
Fig. 6

- S1 REFERENCE POSITION DEPRESSED?
- S2 OUTPUT BEEP SOUND
- S3 STORE VOLUME VALUE
- S4 SETTING TO OPTIMUM VALUE
- S5 START TIMER
- S6 SLIDE PERFORMED IN RIGHT DIRECTION?
- S7 VOLUME UP PROCESSING
- S8 SLIDE PERFORMED IN LEFT DIRECTION?
- S9 VOLUME DOWN PROCESSING
- S10 TIME-OUT?
- S11 RETURN VOLUME VALUE TO ORIGIN
- S12 SLIDE OPERATION COMPLETED?
- S13 STOP VOLUME ADJUSTMENT
